## TECHNICAL MEMORANDUM

RE: EPA Contract No. EP-W-12-009

Task Order (TO) 1006, Site Assessment and Remediation at Western Gas

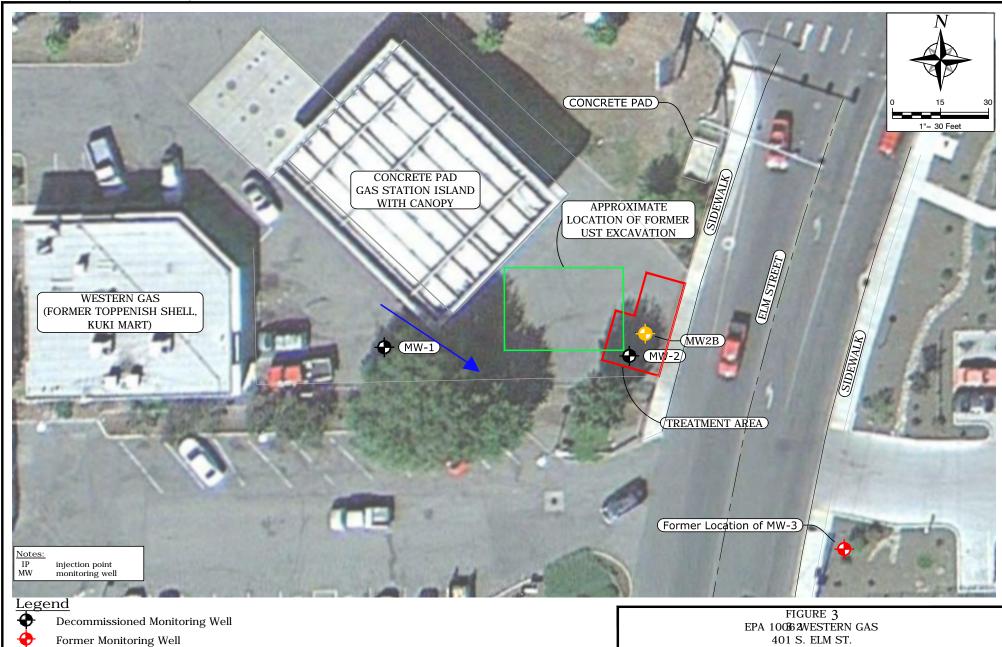
401 S. ELM ST. TOPPENISH, WA 98948 SITE MAP

The Western Gas Site is located on the Yakama Indian Reservation at 401 S. Elm Street, Toppenish, Washington (Figure 1). The site is 0.9 acres, bounded by 1st Avenue to the north, a Taco Bell and Kentucky Fried Chicken to the south, Elm Street to the east, and El Gallo Giro Grocery and Taco Shop to the west. The site supports a concrete pad, a gas station island with canopy, and the Western Gas convenience store (Figure 2). The majority of the site is paved. EPA Region 10 lists the site as an active LUST site (EPA, 2012) and identifies it as EPA Facility No. 4260105.

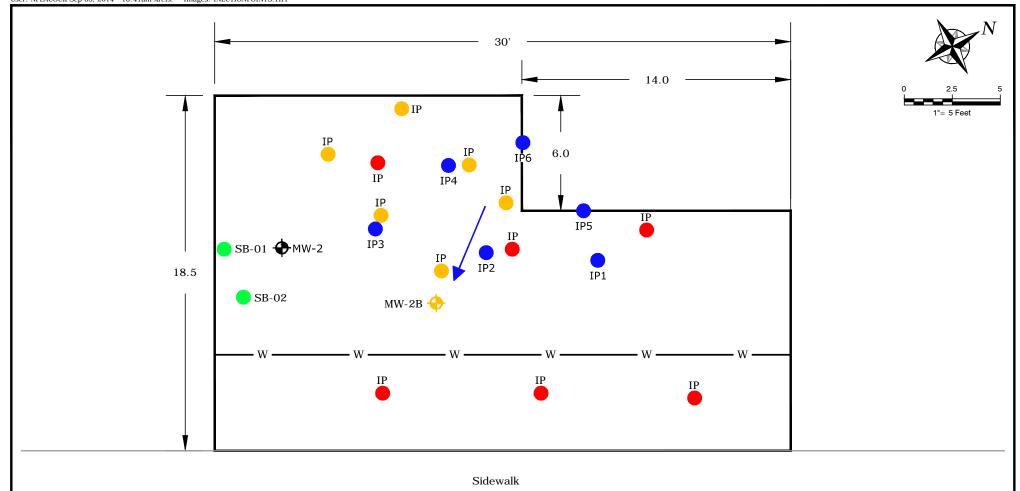
Only one underground utility was identified through these means: a landscape irrigation water line runs through the area, but it is currently not in use (Figure 2). A gas line was identified along the southern edge of the property, between Western Gas and the Taco Bell and Kentucky Fried Chicken.

The treatment area was defined in the *Corrective Action Plan* as a rectangle measuring 30 feet long by 15 feet wide, located between the former soil excavation and Elm Street. Figure 3 depicts the six injection points from this third round of injections, as well as the twelve injection points from the first two rounds of injections. Based on Regenesis' recommendation, the injection points were offset by approximately 4 feet from the previous

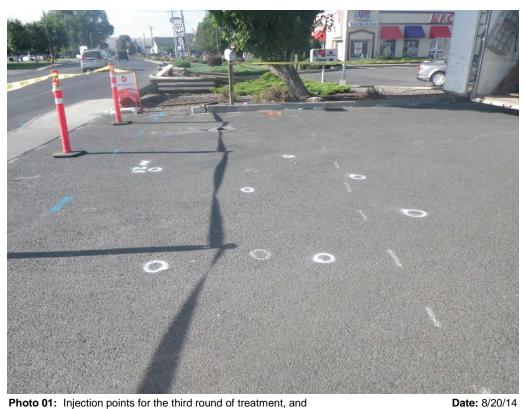
**Photo 01:** Injection points for the third round of treatment, and replacement monitoring well MW-2B location.

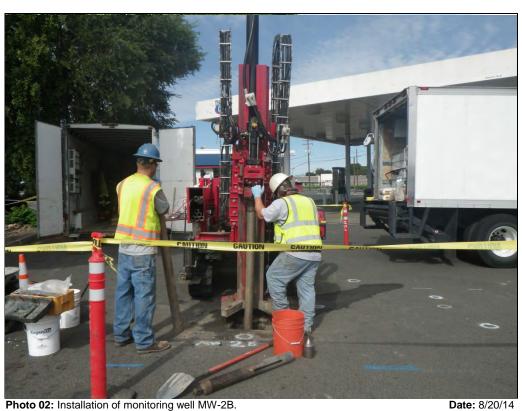
Photo 02: Installation of monitoring well MW-2B.

Bristol's subcontractor PS&W installed and developed replacement compliance well MW-2B. The well is a 2-inch diameter, schedule-40 PVC, flush-mounted well that was installed to 20 foot bgs with a direct push drill rig. The well has a 10-foot long, 2-inch diameter pre-packed screen with 20/40 sand and a 65 mesh stainless screen; the screened interval is from 8 to 18 feet bgs. The annular space between the filter pack and the borehole wall was filled to 2 feet above the top of the screen with 10/20 sand. Two feet of bentonite chip seal was placed above the sand. Granular bentonite was used to seal the well to near ground surface. Bristol installed the flush surface monument by cutting a 2- by 2-foot square through the asphalt,

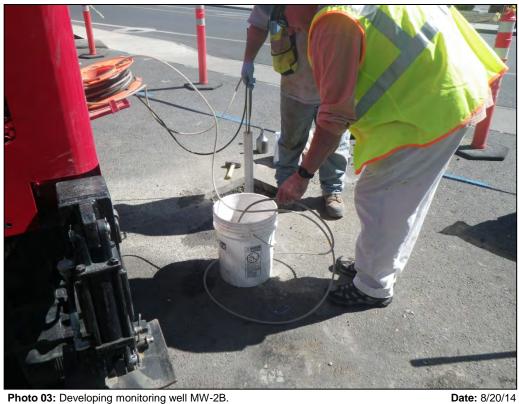
Photo 03: Developing monitoring well MW-2B.

The new well was developed within two hours of installation. Granular bentonite, which hydrates in approximately one hour, was used to seal the well instead of grout because the granular bentonite will not be pulled down the sand pack during well development. Well development consisted of routinely surging and purging the well with a 2-inch-diameter surge block until relatively clear water was produced and all water quality parameters, with the exception of turbidity, stabilized. The calculated well volume was 5 gallons, which, if three well volumes were removed, would result in approximately 15 gallons of development water that would need to be removed to properly develop the well. After removing 35 gallons of development water, turbidity was still higher than the criteria specified in the QAPP. After consulting the EPA SME, Bristol stopped development and let the well rest for an hour before sampling; samples would be collected after 30 minutes if the turbidity did not stabilize during the low-flow purging.

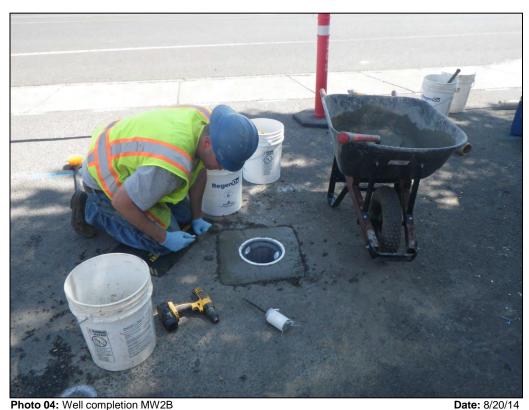
Photo 04: Well completion MW2B

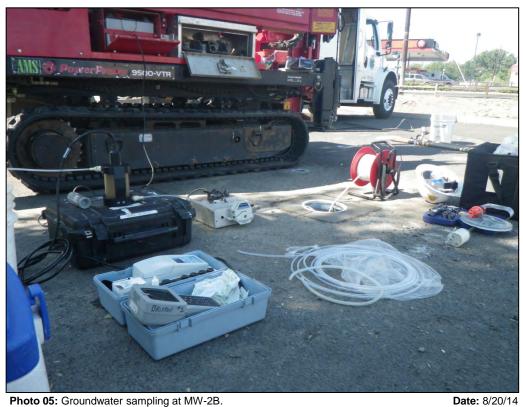
Photo 05: Groundwater sampling at MW-2B.

Bristol began low-flow purging of MW-2B an hour and a half after the well was developed. Water quality parameters were monitored every 3 to 5 minutes until all parameters stabilized. All the measured parameters stabilized within 30 minutes, with the exception of turbidity, which remained over 500 NTU.

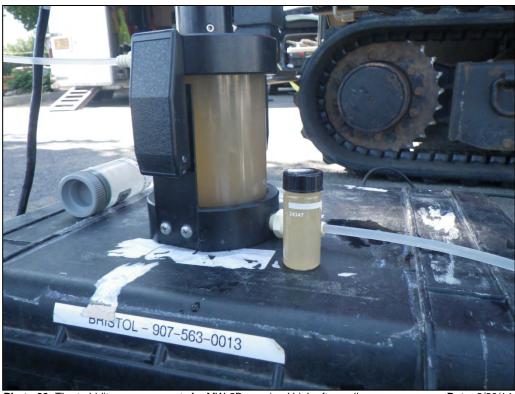
Photo 06: The turbidity measurements for MW-2B remained high after well development and purging prior to sample collection..

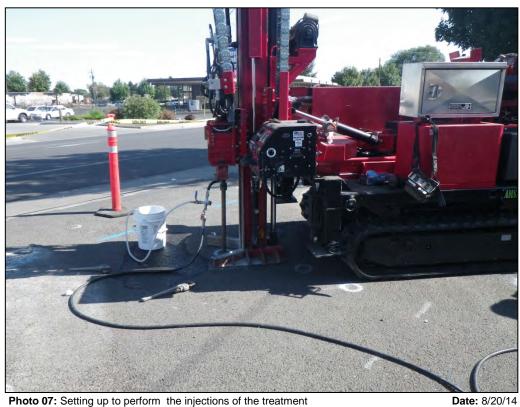
Photo 07: Setting up to perform the injections of the treatment

solution.

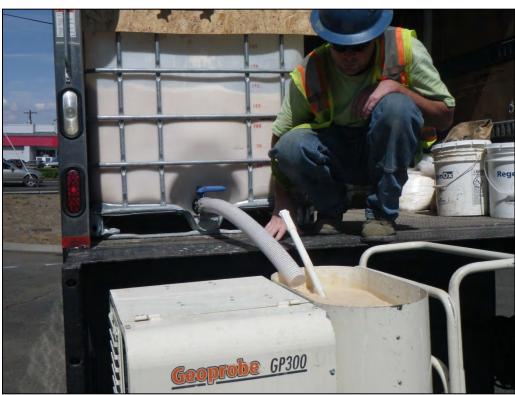
Photo 08: The treatment reagents were mixed in a hopper prior to injection.

The RegenOx and ORC Advanced reagents for each injection point were mixed in 5-gallon containers, added to a poly tank containing 150 gallons of water, and mixed continuously until injected. The poly tank was staged on a platform so that the valve was located above the injection pump, allowing the solution to be gravity-fed into the pump's hopper. Once well mixed, the solution was gravity-fed into a hopper. To inject the treatment solution, the Geoprobe rig was staged at the injection point and the pre-probe with an expendable tip was driven to the bottom of the treatment interval, 18 feet bgs, with standard 1-inch diameter drive rods, and the expendable tip was disconnected.

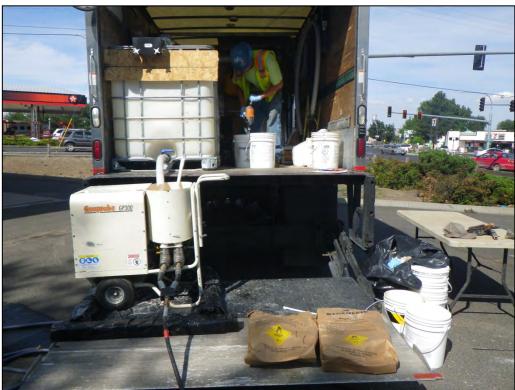
**Photo 07:** The treatment reagents were initially mixed in 5-gallon buckets, then transferred to the hopper for further mixing prior to injecting the solution into the subsurface.

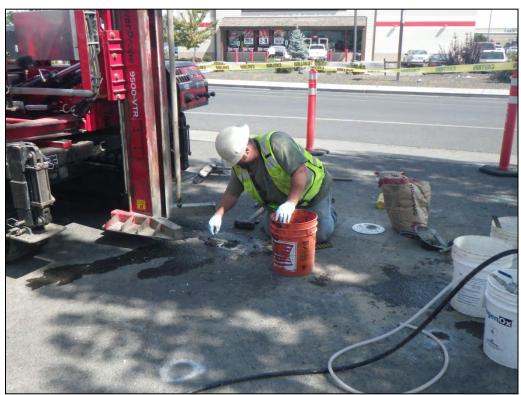
Photo 08: Grouting and applying an asphalt patch at an injection point.

Once the hopper was filled, an injection manifold (outfitted with a pressure gauge and a release valve) was connected to the top of the drive rods, and the injection pump was connected to the injection manifold with a hose. A total of 25 gallons per foot, starting at 18 feet bgs and ending at 12 feet bgs, were injected at each point. Once the injection was complete, the pre-probe and drive rods were removed and the open borehole was slowly filled with bentonite pellets to within 0.5 feet of the ground surface, and hydrated. The borehole was then finished with a surface seal of quick-set concrete and an asphalt patch.

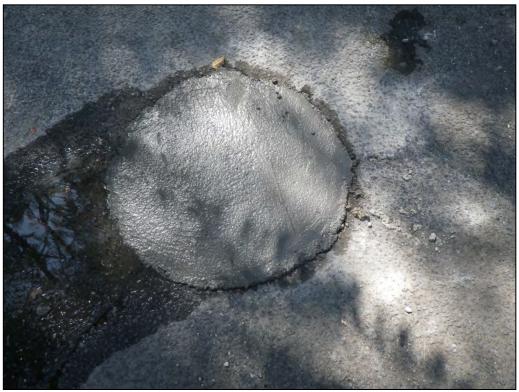
**Photo 07:** Decommissioned MW-1. **Date:** 8/21/14 **Direction:** Ground **Photographer:** P. Braley

Bristol decommissioned the two onsite groundwater monitoring wells, MW-1 and MW-2, by removing the protective covers, filling the 4-inch wells with bentonite chips to the top of the well, and then hydrating the bentonite with water. After the bentonite was hydrated, asphalt was placed over the top to patch the hole. The concrete well pad was broken up using a jackhammer, and disposed offsite.

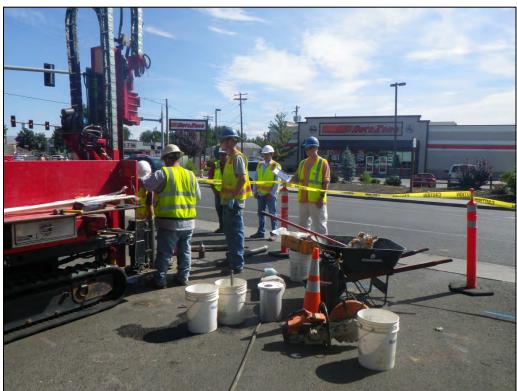
**Photo 08:** The EPA Subject Matter Expert provided direction on the location for the replacement well MW-2B, and the location of the injection points.
